The Airbus Safety Magazine

01 | January 2005 |

Editorial Y. Malinge	2
News C. Courtenay	4
Go-Arounds in Addis Ababa due to VOR Reception Problems J. Daney	5
The Importance of the pre-Flight, Flight Control Check A. Urdiroz	11
A320 In-flight thrust reverser deployment T. Thoreau	17
Airbus Flight Safety Manager Handbook C. Courtenay	22
Flight Operations Briefing Notes C. Lemozit & M. Tremaud	23
Airbus Flight Safety Contacts/Organisation	26

Go-Arounds at Addis Ababa due VOR Reception Problems

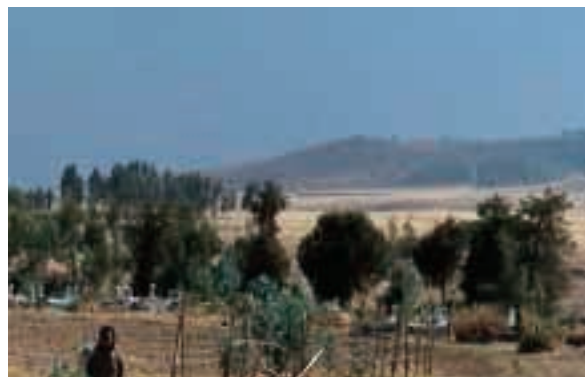
This photograph shows the NW to SE ridge running down towards the approach path. It was taken from near the village of Leghedadi 10nm NW of the airport looking WSW from a range of approximately 5nm.

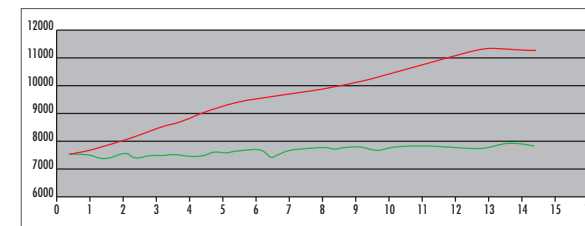
Figure 1 shows the profiles for the approach carried out on the return from Djibouti which was carried out visually. The terrain profile is typical for a correct approach path with the characteristic gentle slope of the plain from west to east. Other characteristic features are the river valley at 6.5D and the double depression on the final approach to the threshold.

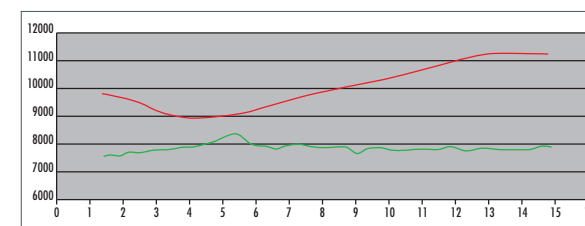
Figure 2 shows the profiles for the first approach at HAAB. Notable points are the non-sloping nature of the terrain between 15nm and 6nm and the high point at just over 5nm. There is also a marked valley at 9nm and a lesser one at 6.5nm.

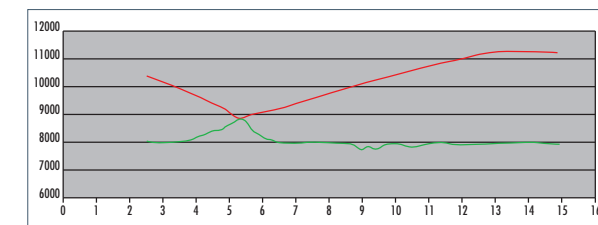
Figure 3 shows the profiles for the second approach at HAAB. Here, the notable points are again the flat terrain between 15nm and 7.5nm and the high point at just over 5nm. The river valley is still apparent at 9nm, but has split into two. The terrain clearance at the point of go-around is 55'.

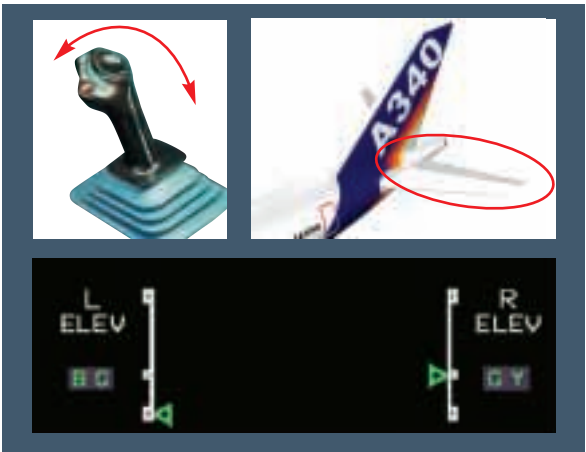
Figure 5

A few events of this kind have been experienced with aircraft of the A340 family. The crew detected during the pre-flight F/CTL check that one elevator was stuck down (Figure 5). The loss of the elevator control was not indicated to the crew by any warning.

These events resulted from failure of the servo-control in damping mode failed. Investigating these events has allowed definition of modifications to both the servocontrols and the F/CTL computers in order to prevent similar events. Appropriate ECAM warnings are triggered for crew annunciation. For these events, detection was ensured by carefully performing the existing SOP F/CTL Check only. Additional information about these event is available with

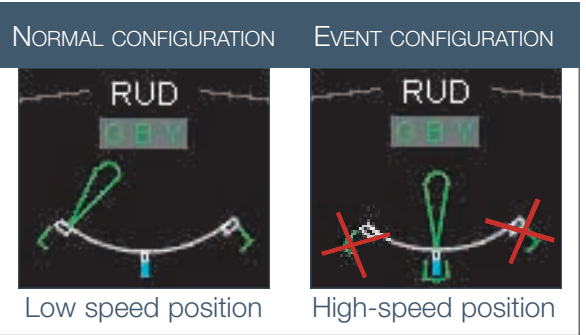
Figure 6: Full rudder deflection not achieved

The Rudder Travel Limitation Unit (RTL) had failed closed in the high-speed configuration. The ECAM warning "F/CTL TRAVEL LIM FAULT" dedicated to the monitoring of the RTL position was not displayed.

Indeed, at that time, FCSC which is the computer that controls the RTL and PTLU did not monitor their behaviour during phases when they are not electrically supplied and thus not supposed to move. However the RTL system failed and RTL closed during such a phase of no monitoring on ground. Monitoring has since been reviewed.

The failure was thus detected only by performing the existing SOP F/CTL Check, and the right decision to return to the gate could be taken.

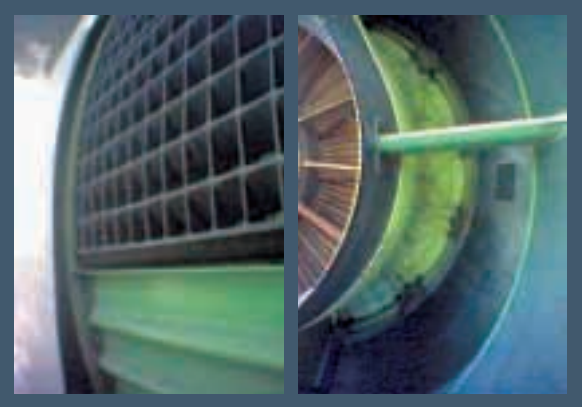
Figure 1

- Upon landing, the engine N° 1 reverser was found almost fully deployed.

- The thrust reverser sleeve locking pins (2) were not found, while the lock-out assembly was intact.
- After opening the fan cowls, both locking actuators were found lock wired in the unlock position. The HCU was properly deactivated.

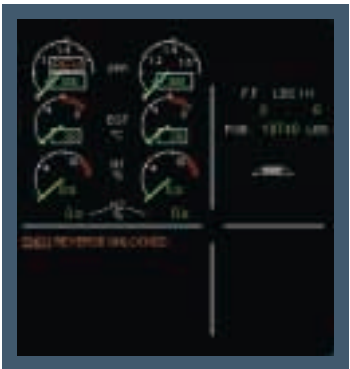
Figure 2

Prior to engine start, the ECAM warning “ ENGX REVERSE UNLOCKED” was annunciated.

According to information received, maintenance personnel cancelled the “ENGX REVERSE UNLOCKED” message through the “EMER/CAN” button.

The “ENGX REVERSE UNLOCKED” and the “REV” Amber messages should not be present on ECAM following a proper thrust reverser deactivation. **They are both NO DISPATCH warnings.**

In addition, the “EMER/CANC” button should only be utilized to kill a permanent spurious warning.

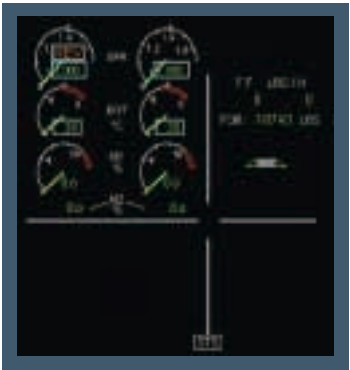
Figure 3

Upon engine start, the “ENGX REVERSE UNLOCKED” warning was then displayed under cancelled cautions, while the ECAM showed “REV” Amber in EPR gauge and “STS” indication.
