# Safety **First**

The Airbus Safety Magazine

**# 6**

JULY 2008

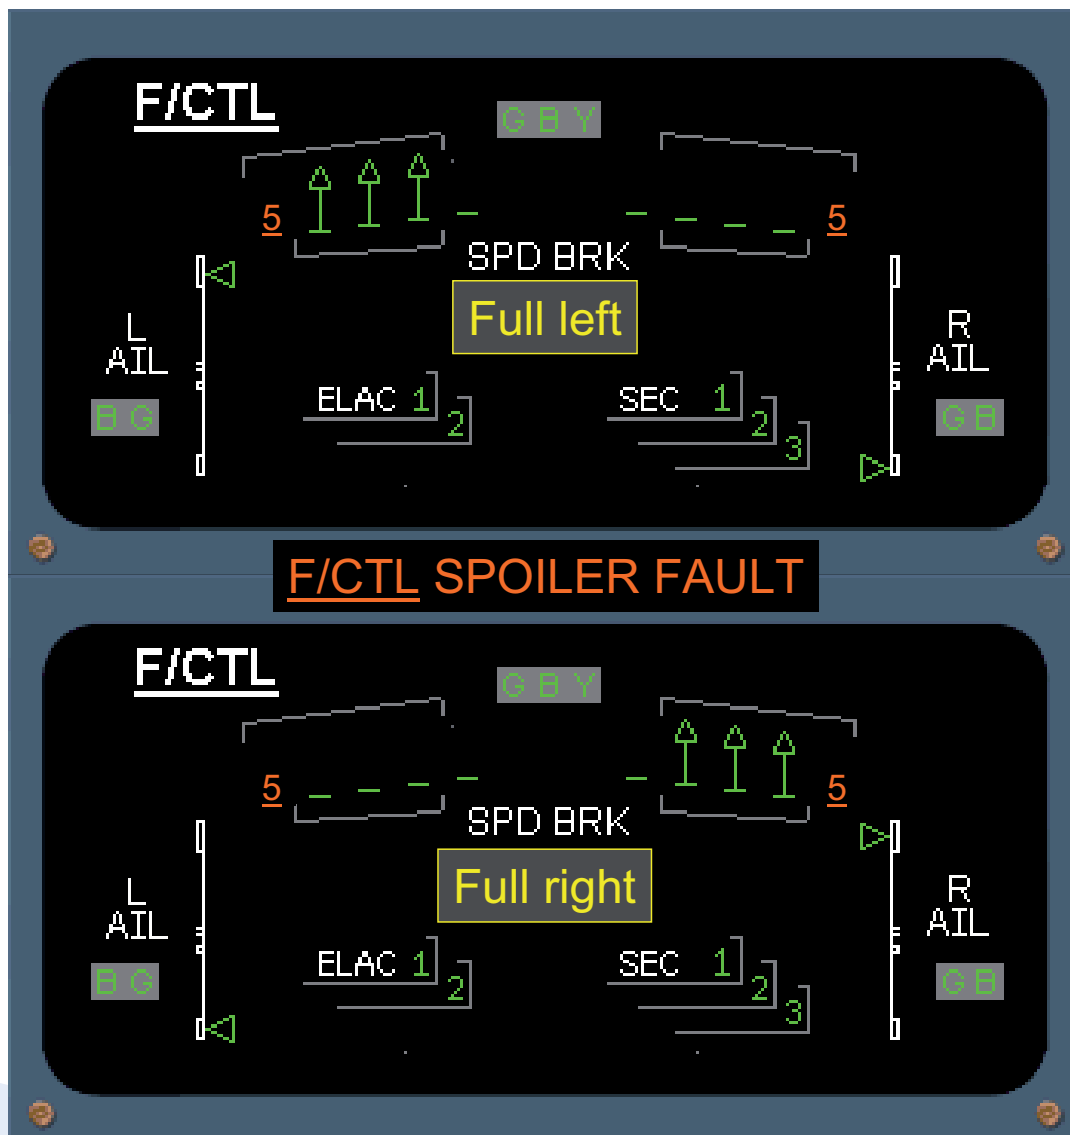
Figure 1: Spoiler 5 fault during F/CTL check

**F/CTL SPOILER FAULT** was triggered, and spoiler shown as FAULT RETRACTED (5) on the ECAM F/CTL page.

Figure 1 illustrates the messages displayed on the F/CTL page of their ECAM.

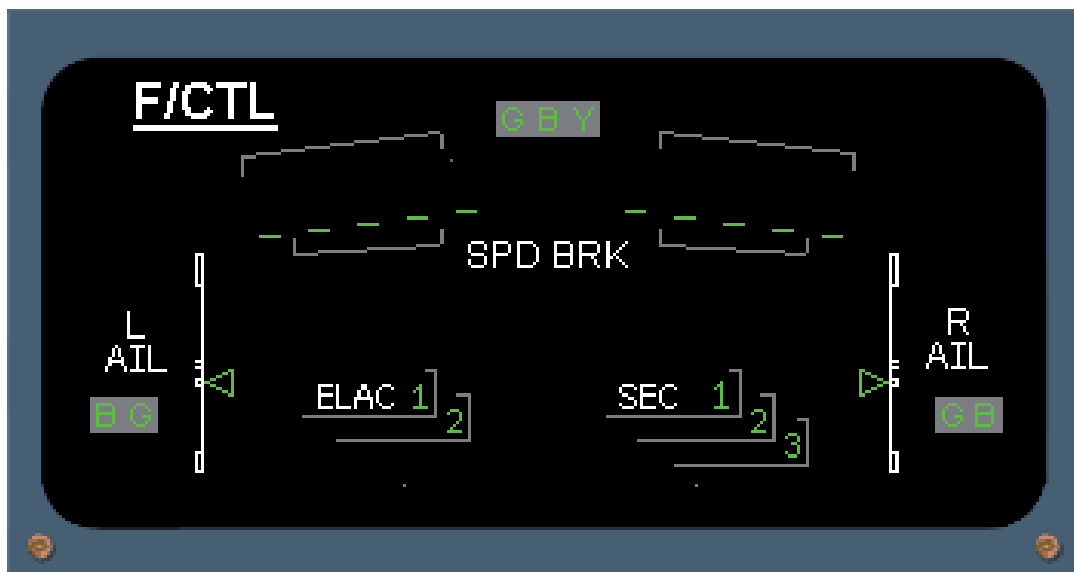
Figure 2: All GREEN after SEC reset

i.e. F/CTL SPOILER FAULT cleared and spoilers 5 were displayed back to GREEN on the F/CTL page (fig.2).

Through the SEC reset, the monitoring system of the spoilers was reinitialized and this cleared the fault message. The faulty condition, however, remained.

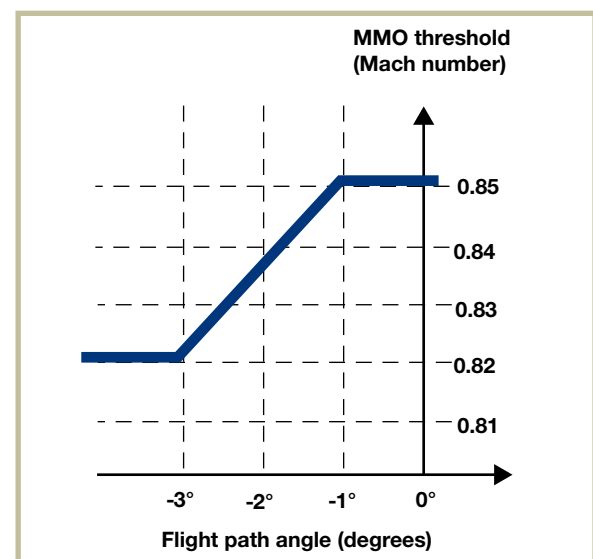
Figure 3: L84/L93 Mach threshold for HSP activation/AP disconnection.

In the L84/L93 standards, the Mach threshold is a function of the Flight Path Angle and is identical for the whole A320 family. The main aim is to have a better protection of the aircraft during cruise (*fig. 3*).

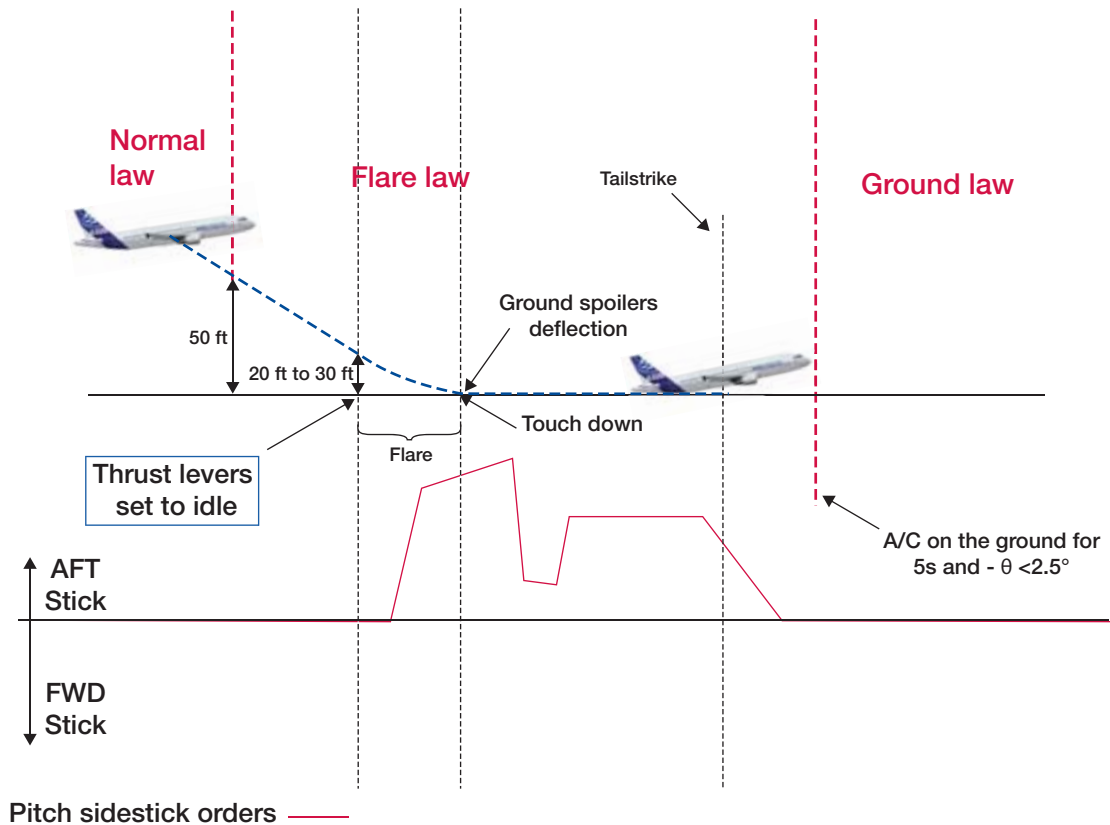
Figure 1: Normal landing with sidestick maintained AFT after the touch down.

The importance of this subject is obviously correlated to the fuselage length. It is, therefore, particularly important to A320 and A321 operators.

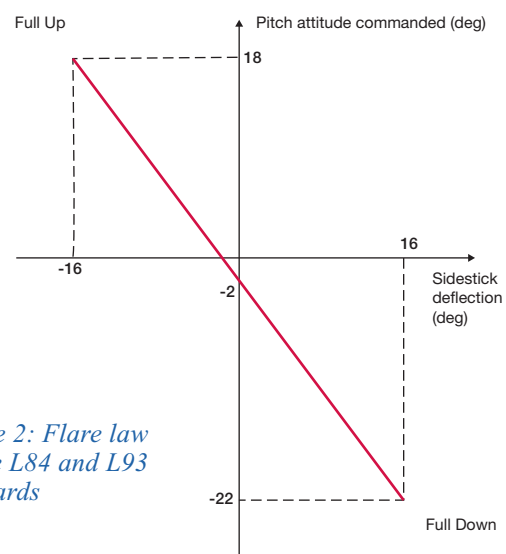
Figure 2: Flare law before L84 and L93 standards

- A pitch sidestick deflection corresponds to a commanded pitch attitude.
- The maximum commanded pitch attitude with full back stick is 18 degrees (fig. 2).

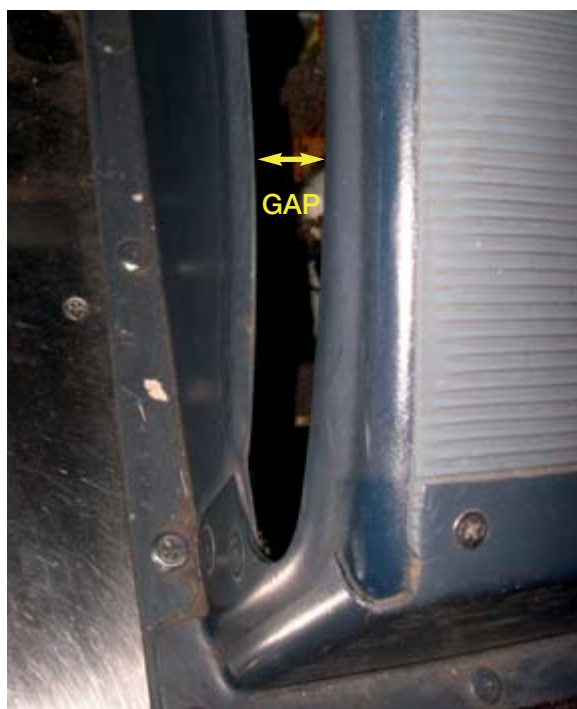
The original cockpit pedals assembly covers presented a 5 cm open gap, to allow free movement of the rod connecting the pedal to the brake mechanism.

This unprotected gap let objects like pens or calculators slip into the braking mechanism.

*Protective cover  
with no brush*

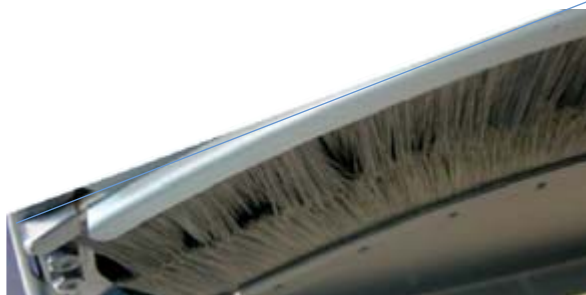
*Detail of brush*

The first events were reported on A340 aircraft and new pedal covers with brush were developed for the A330/340 family. Due to similarity in design, a similar cover was introduced on the A320 family as well.

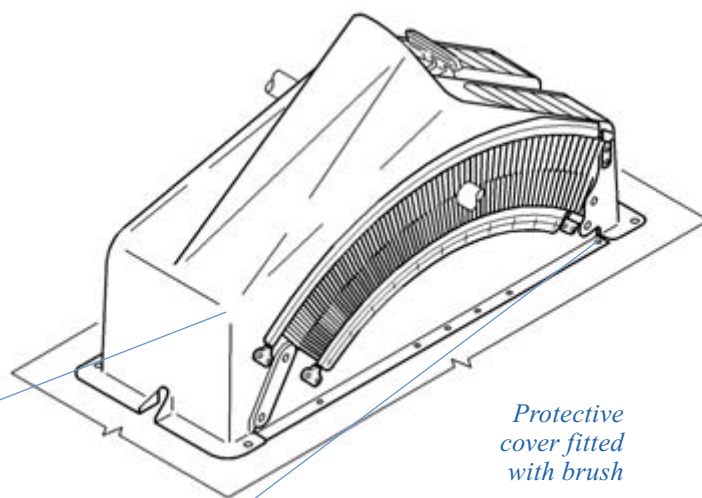
*Protective cover fitted with brush*

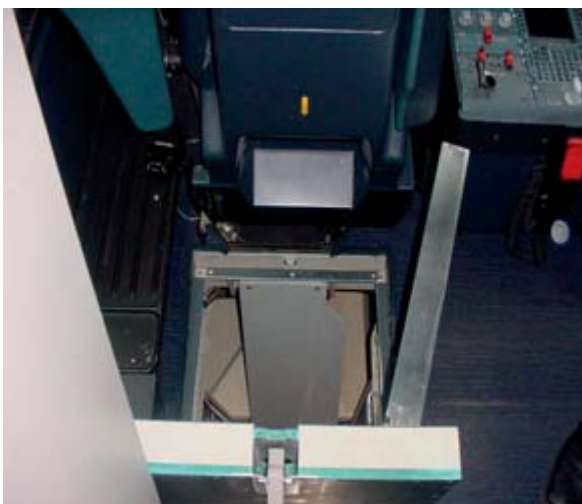
Figure 1: Open access hatch seen from cockpit door (prototype of protective arm shown)

Airbus has received reports of cabin attendants falling through the avionics hatch door located in the cockpit, when it is open for maintenance purposes. In most of the cases the cabin attendant hurt him/herself only slightly and could continue his/her duty. But there were also some occurrences where the cabin attendant couldn't continue his/her duty. In 2001, an OIT (ref.: AI/SE 999.0002/01) was published to inform operators about such events and to provide some general recommendations. In addition, Airbus has developed a device that should contribute to prevent such mishaps.

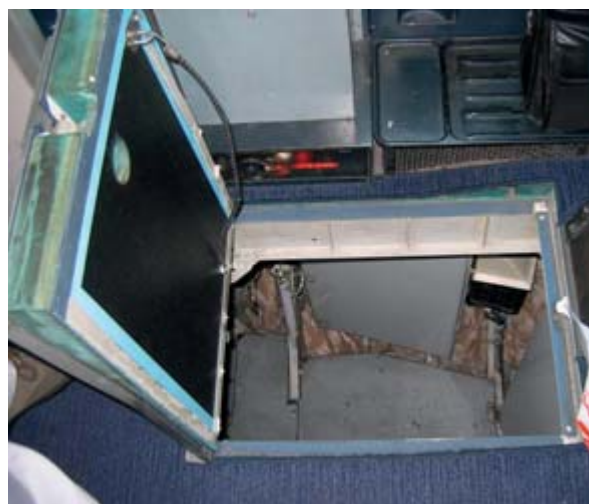
Figure 2: Open access hatch seen from behind the first officer's seat

The avionics compartment access hatch is located in the cockpit behind the captain's seat. It opens upwards from front to back. When the hatch is open, it rests vertically and covers approximately 80% of the corridor width. This makes the hatch position noticeable and requires care to be taken to move around it when entering the cockpit. Therefore anyone entering the cockpit while the hatch is open should notice it (see fig. 1 and 2).
