# Safety **First**

The Airbus Safety Magazine

FEBRUARY 2009

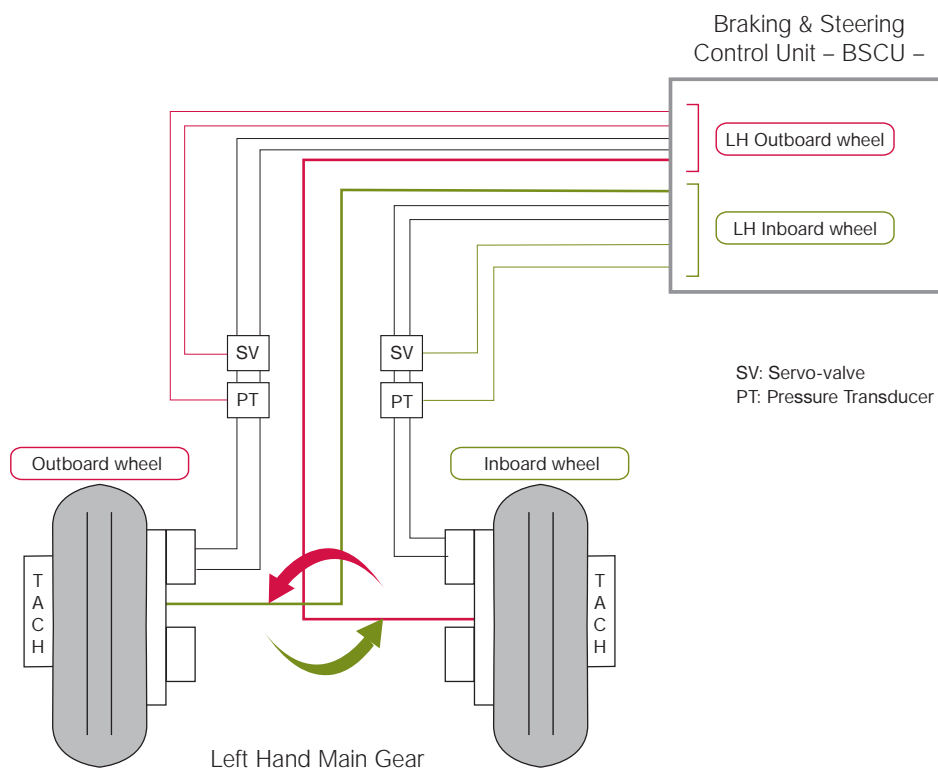
*Figure 1: Schematic of tachometer cross connections*

- A few cases of Main Landing Gear — MLG — tachometer cross connections have been reported. These cross connections were done at the level of the wheels axis, as shown on figure 1.

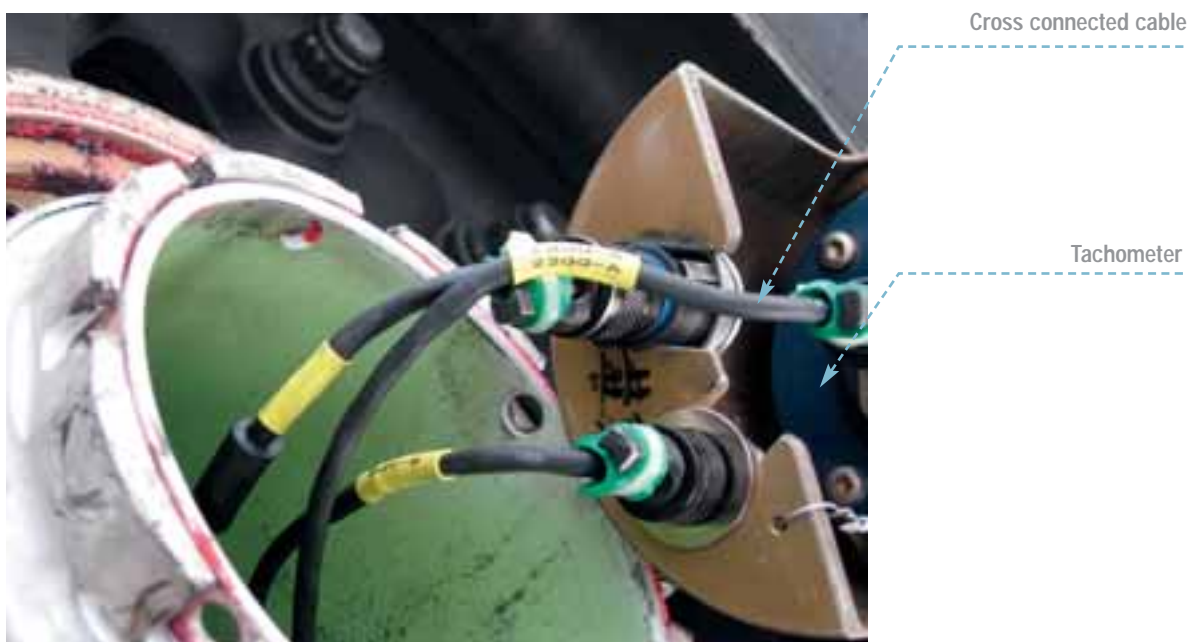
*Figure 2: Picture of tachometer cross connections*

Figure 2 shows an actual cross connection on the right hand side main gear. The cable labelled 19GG-A/22GG-A connected to the tachometer (the blue cylindrical equipment

which can be partially seen on the right hand side of the picture), should in fact have been the cable 20GG-A/21GG-A.

Crossed cables in the braking system have, in the past, caused incidents. It is therefore important to comply strictly with the published maintenance procedure.

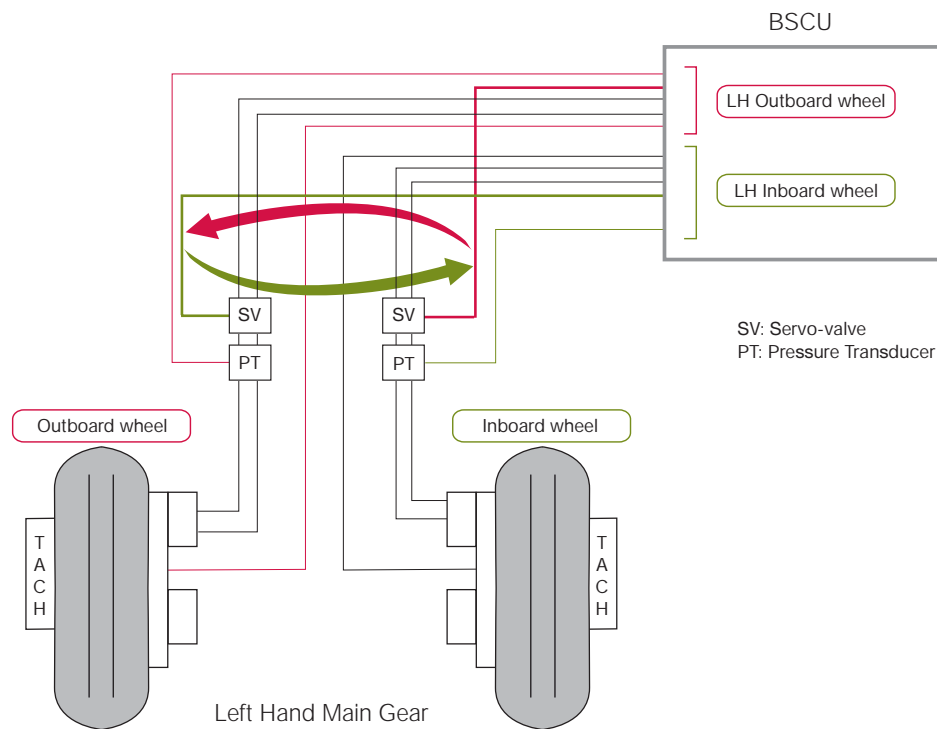
*Figure 3: Schematic of servo-valve cross connections*

It involves the connections to the servo-valves, as shown on figure 3.

The lower number of cases that have been reported can be explained by the fact that the flanges supporting the servo-valve cables have different lengths. This type of cross connections are thus more difficult to realize.

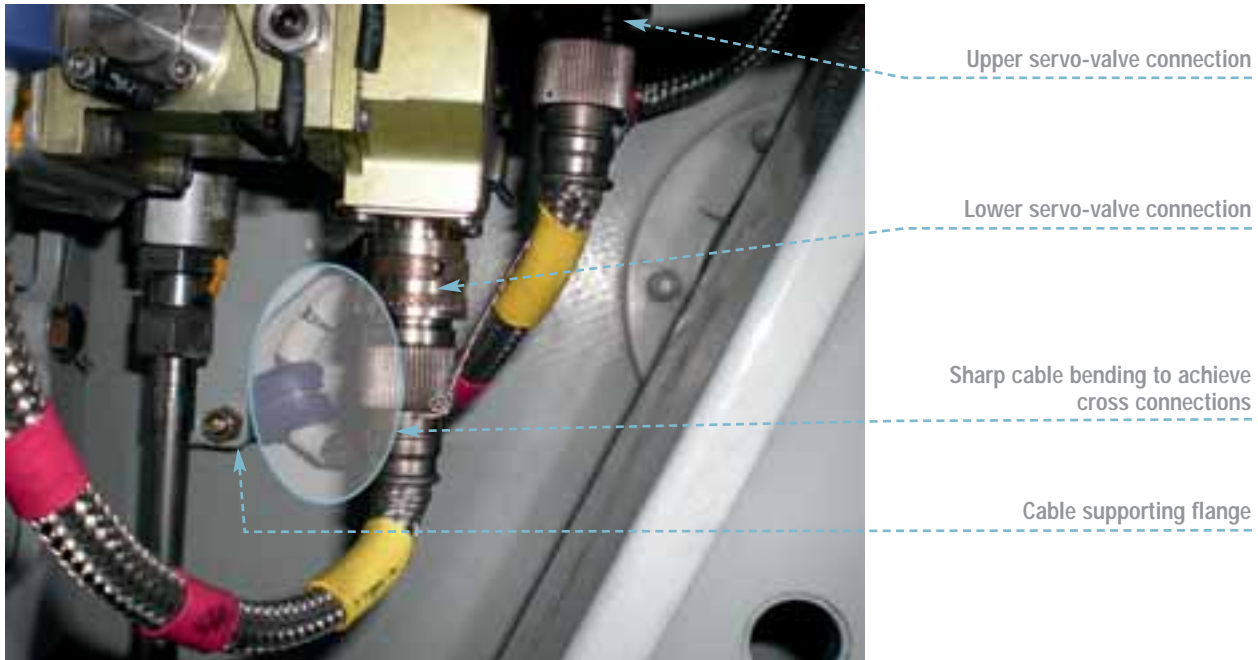
Figure 4: Picture of servo-valve cross connections

It shows that the flange supporting the cable to the lower servo-valve allows an easy connection only on the lower servo-valve.

In this case, the flange forced the cable wrongly connected to the upper servo-valve to make an excessively sharp bend.
