The Airbus Safety Magazine

01 | January 2005 |

Editorial Y. Malinge	2
News C. Courtenay	4
Go-Arounds in Addis Ababa due to VOR Reception Problems J. Daney	5
The Importance of the pre-Flight, Flight Control Check A. Urdiroz	11
A320 In-flight thrust reverser deployment T. Thoreau	17
Airbus Flight Safety Manager Handbook C. Courtenay	22
Flight Operations Briefing Notes C. Lemozit & M. Tremaud	23
Airbus Flight Safety Contacts/Organisation	26

Go-Arounds at Addis Ababa due VOR Reception Problems

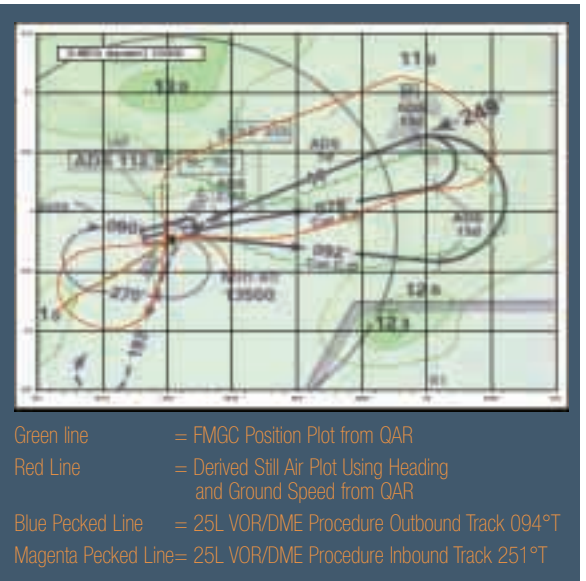
The two approaches flown during the incident flight were both conducted in IMC with only one glimpse of ground lights during the first approach.

Figure 4 on shows the track for the second approach.

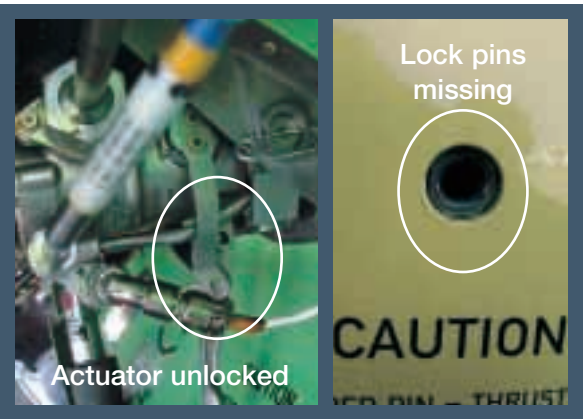
- The HCU deactivation was done properly following the AMM procedure:
 - “A. Deactivation of the Thrust Reverser HCU” procedure.
- The following AMM procedure steps were not performed , because it was not possible to do so while the thrust reverser actuators were lock wired in the unlocked position:
 - “B. Manually move the translating sleeves to the fully retracted position”
 - “C. Lock the Left and the Right Translating sleeves”
- Finally the last AMM procedure step was not done.
 - “D. Put the locking actuators in the locked position”

Due to the combination of having:

- The HCU deactivated (leading to no hydraulic power to the actuators)
- And the actuators not locked
- And the lock-out bolts not properly installed on the translating sleeves,

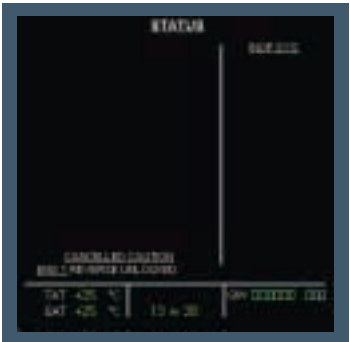
Figure 4

However, the aircraft was dispatched with the thrust reverser unlocked and free to move under aerodynamic forces.
