# Safety **First**

The Airbus Safety Magazine

**# 6**

JULY 2008

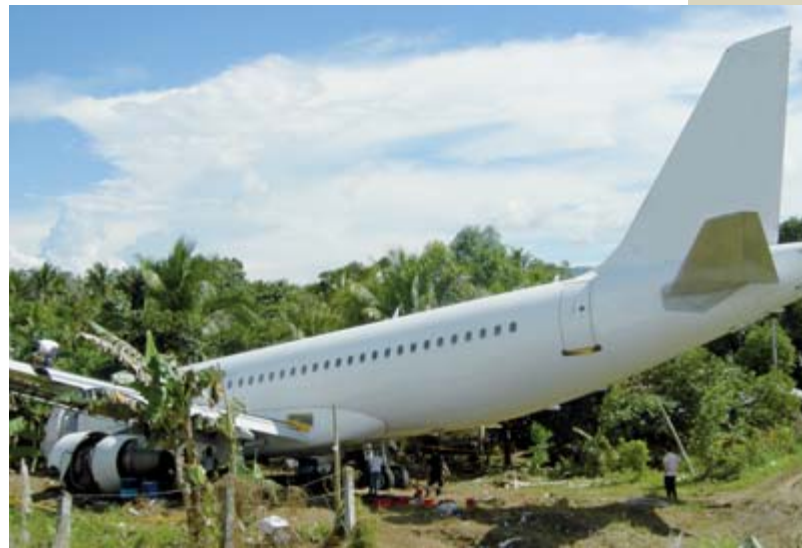
At about 1 150ft RA, during the LH turn to intercept the runway centerline, configuration FULL<sup>5</sup> was selected (CAS was 170kt; VFE = 177kt) and within about one second, speedbrake lever was pushed aft to command extension. To do that, the crew disarmed the ground spoilers.

The F/O announced "High speed he" and immediately after "Let's circle again it's too high" followed by "High".

Slats and flaps surfaces reached the position FULL about 3s after the crew selected this configuration. Speedbrakes started to retract (speedbrakes are inhibited in configuration FULL on A320).

A Single Chime (SC) sounded, which corresponds to the "SPD BRK DISAGREE" caution, triggered because of the difference between the actual position of the speedbrakes (retracted) versus the commanded position (extended).

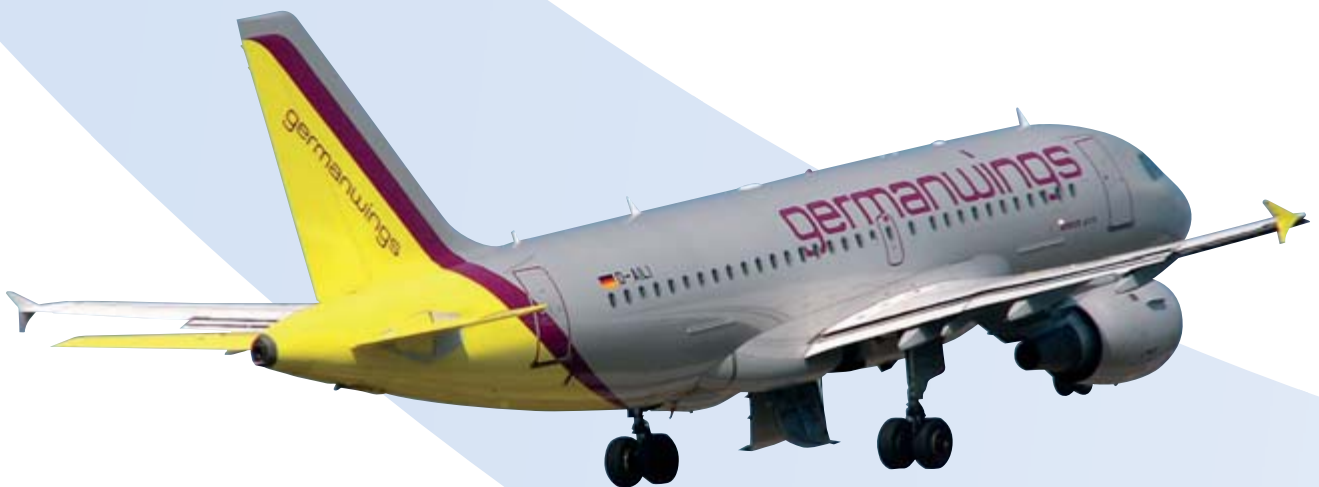
The aircraft was dispatched with a LH spoiler actuator #5 in faulty condition.

i.e. F/CTL SPOILER FAULT cleared and spoilers 5 were displayed back to GREEN on the F/CTL page (fig.2).

Through the SEC reset, the monitoring system of the spoilers was reinitialized and this cleared the fault message. The faulty condition, however, remained.

ELAC or SEC malfunction	ELAC or SEC	
27			<p><b>WARNING :</b></p> <p>Do not reset more than one computer at a time.</p> <ul style="list-style-type: none"> <li>· It is possible to reset flight control computers in flight, event if not requested by the ECAM, provided only one reset is performed at a time: For the ELAC only, in case of uncommanded maneuvers during the flight, it is not recommended to reset the ELAC.</li> </ul> <p><b>Note :</b></p> <ul style="list-style-type: none"> <li>· When an ELAC reset is performed on ground the crew must check the pitch trim position.</li> <li>· If a reset is performed on ground, the flight crew must then perform a flight control check, as per SOP.</li> </ul>

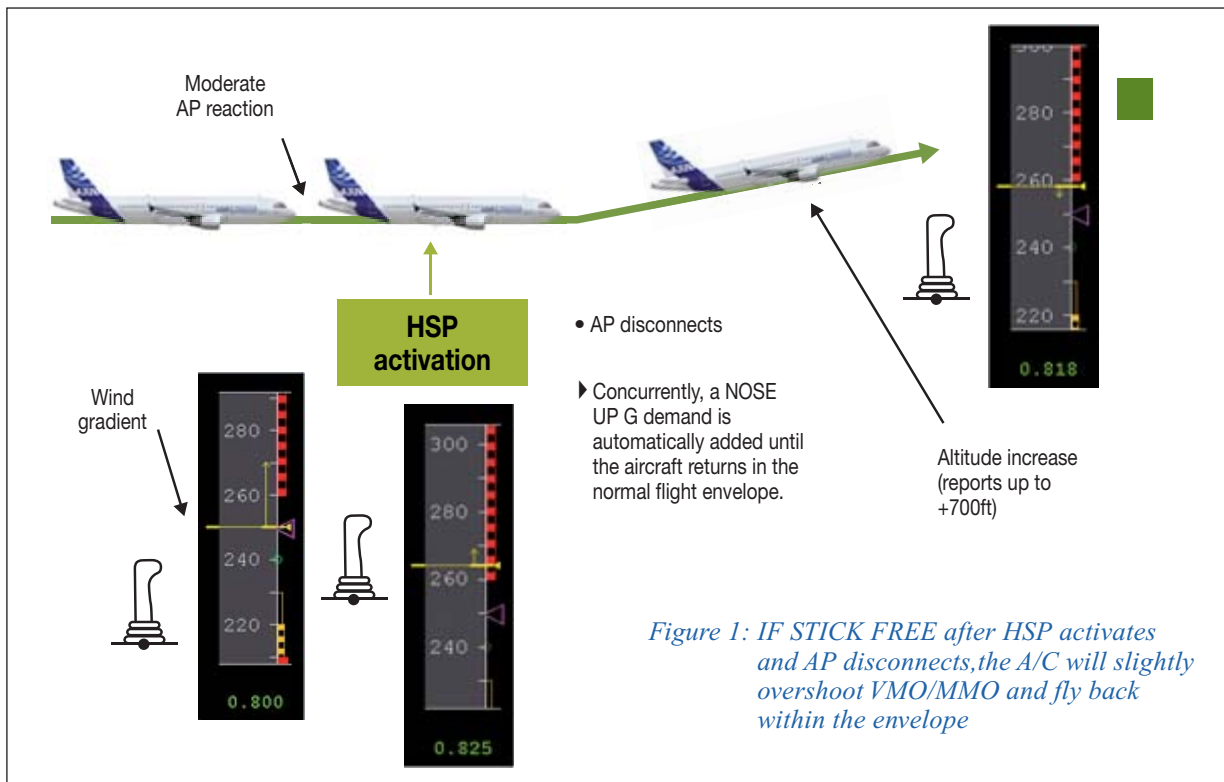
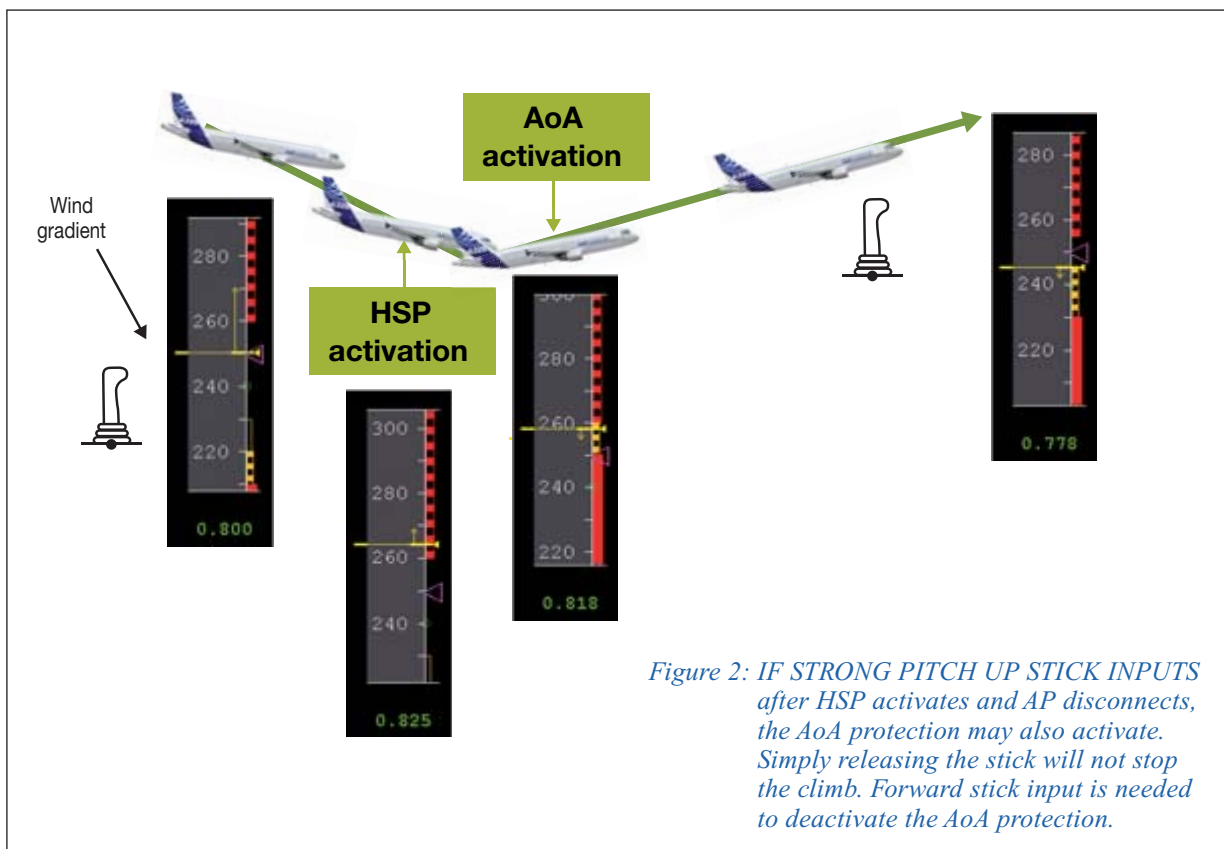
The aircraft typically has the Auto Pilot engaged, and the wind gradient will lead it to exceed the High Speed protection (HSP) threshold (the speed or Mach number at which the HSP activates depend on the flight conditions, but do not exceed  $VMO+6kt$  or  $MMO+0.015$ ). The triggering of the HSP will automatically disconnect the Auto Pilot.

This means that the aircraft will climb at the highest AOA value for as long as the protection is activated. Since deactivation may only be achieved through nose down side stick input, simply releasing the stick will not stop the climb.

Delayed reaction from pilots in applying forward stick input results in large altitude excursions (*fig. 2*).

In order to avoid significant altitude excursions and AP disconnection unawareness in case of VMO/MMO exceedance, Airbus recommends installation of :

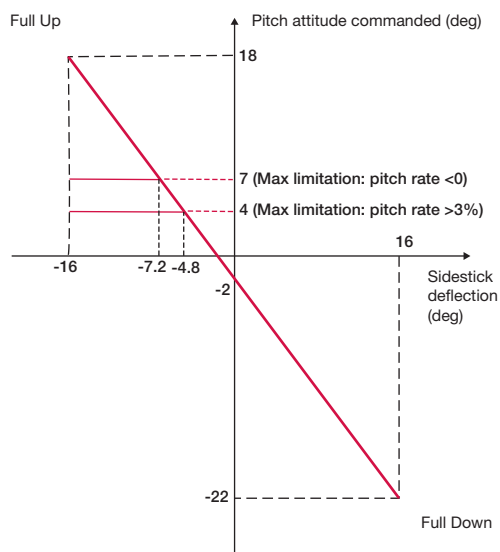
Pitch rate change		
< 3°/s		>3°/s
A320	9°	6°
A321	7°	4°

This limitation is triggered by the ground spoiler extension, thus ensuring that it will be active only during landing. It is therefore deactivated during the take off and go-around phases.

Simulations with the improved control laws have confirmed the following:

- No impact on the landing performance
- The usual flare is not modified
- No interference in case of go-around or during take off due to the ground spoiler condition

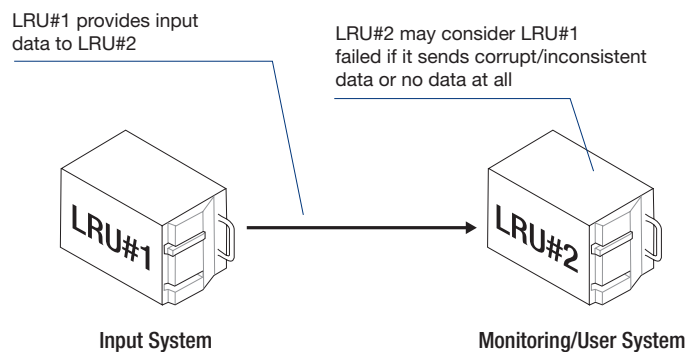
The reset is often necessary to clear faults recorded by systems before or even possibly during maintenance. Some systems (the example below illustrates this) use fault latching mechanisms. That is to say that once a fault has been detected, the input system will be considered unavailable until the user system is next reset.

Typically if maintenance actions are performed to correct a given fault, it can be necessary to reset user systems to ensure that they consider the input system operational again.

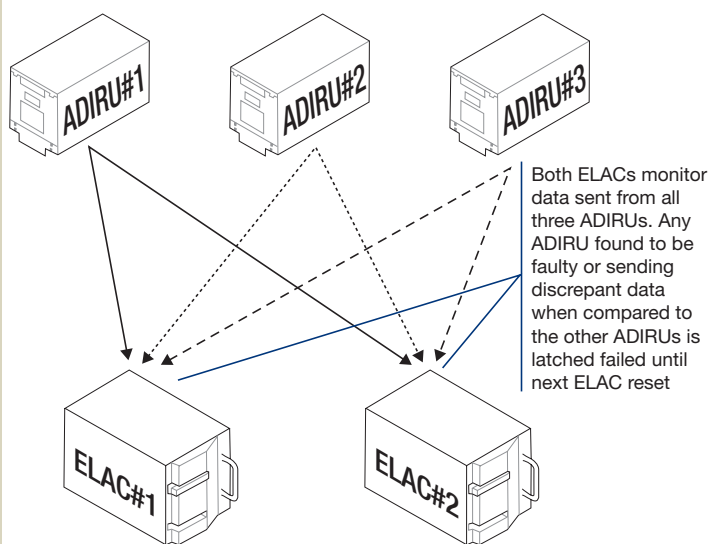
Airbus recently investigated an event in which it was found that an aircraft departed in Alternate Flight control law following maintenance actions not performed fully according to AMM procedure. The circumstances of this event were as follows: During flight an ADR#1 (Air Data Reference) fault was detected. The ELAC (Elevator and Aileron Computer) on detecting this fault, latched the ADR#1 as failed until its next reset. The ELAC subsequently used only ADR#2 and #3 data for calculations.

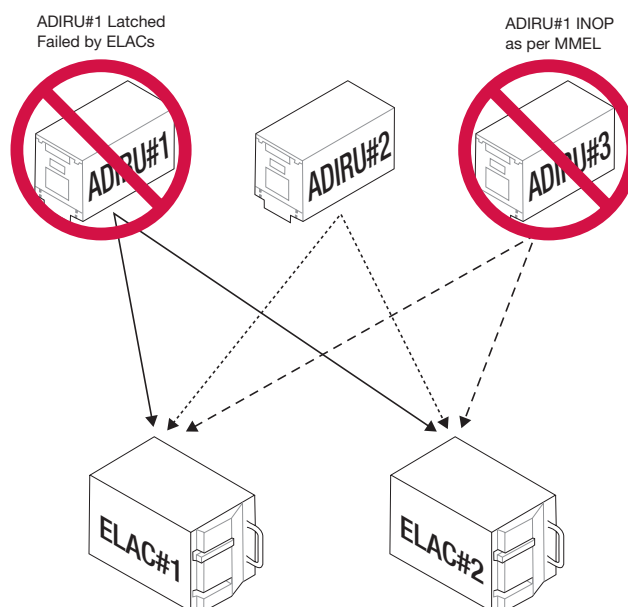
Upon landing, the maintenance crew swapped ADIRU#1 and #3, consequently the faulty ADIRU#1 became ADIRU#3. ADIRU#3 was therefore placed INOP as per MEL and the aircraft dispatched. At no point was an ELAC & SEC reset or aircraft electrical power reset performed. The consequence of this was significant: the ELAC kept its memory of ADR#1 Fault latched from the

previous flight. In addition it detected that the ADR#3 was INOP. Without ADR#1 or #3, only ADR#2 was considered available. Under these conditions the Electronic Flight Control system is only capable of operating in Alternate Law.

Had the maintenance crew correctly followed the AMM, including the ELAC reset, then the ADR#1 fault latched by the ELAC would have been reset and the Alternate law condition avoided.
