# Safetyfirst

The Airbus Safety Magazine

Edition January 2011

- What is stall?  
How a pilot should react  
in front of a stall situation
- Minimum control speed tests  
on A380
- Radio Altimeter erroneous values
- Automatic NAV engagement  
at Go Around

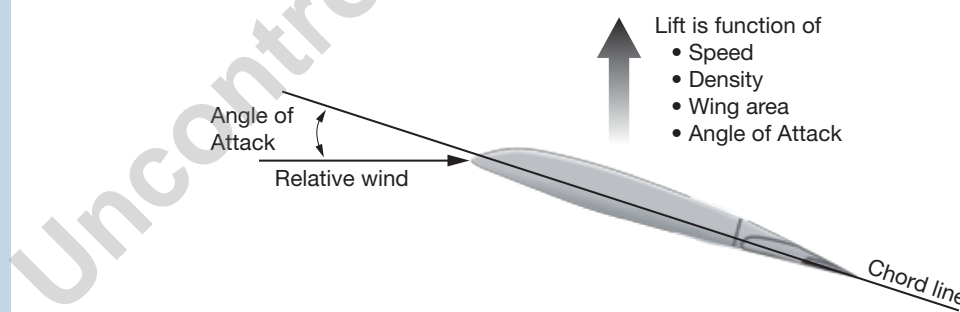
$V$  = True Air Speed

$C_l$  = lift coefficient of the wing

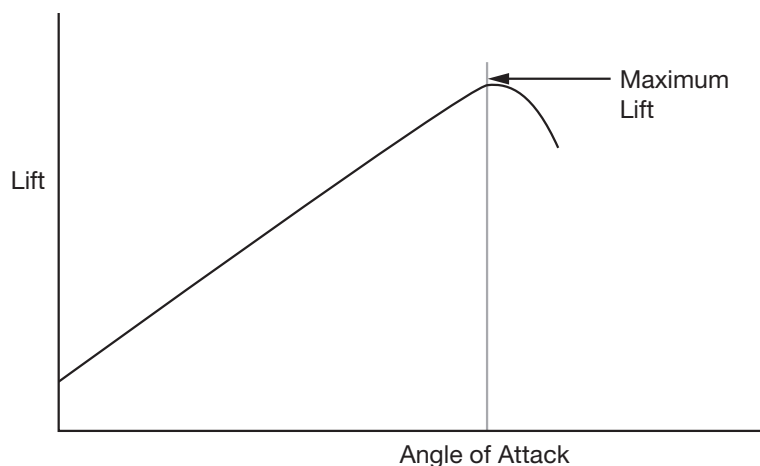
The lift coefficient increases as a function of the Angle of Attack (AoA) up to a value, called Maximum lift, where it starts to decrease.

For a given configuration, a given speed and a given altitude, the lift is only linked to the AoA.

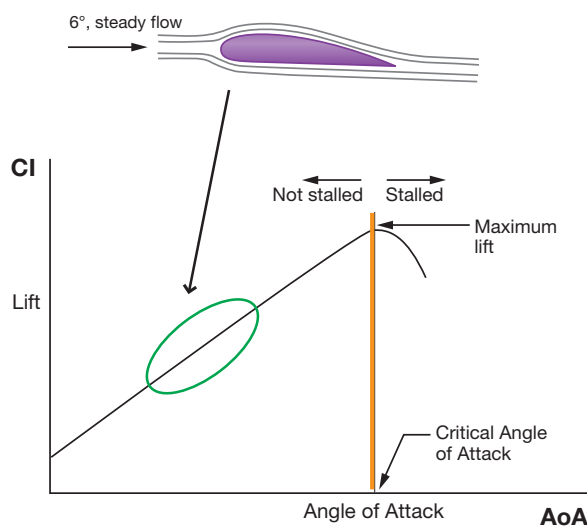
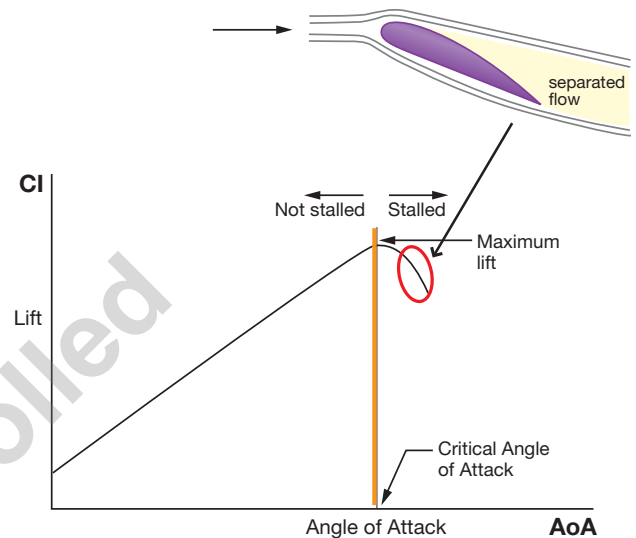
The linear part of the curve corresponds to a steady airflow around the wing.

Beyond this point, the lift decreases as the flow is separated from the wing profile. The wing is stalled.

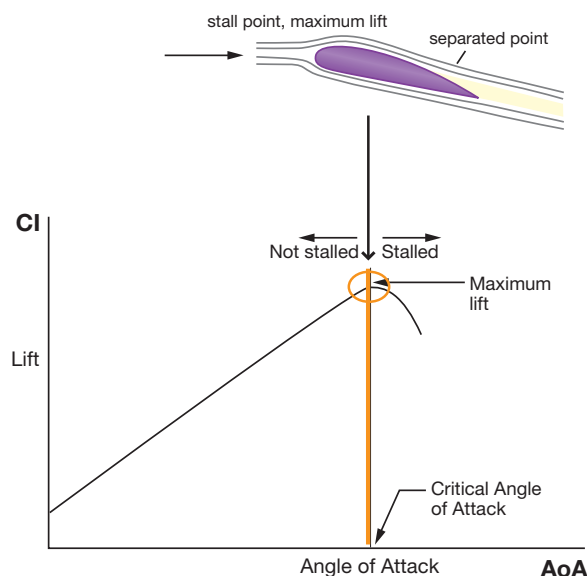
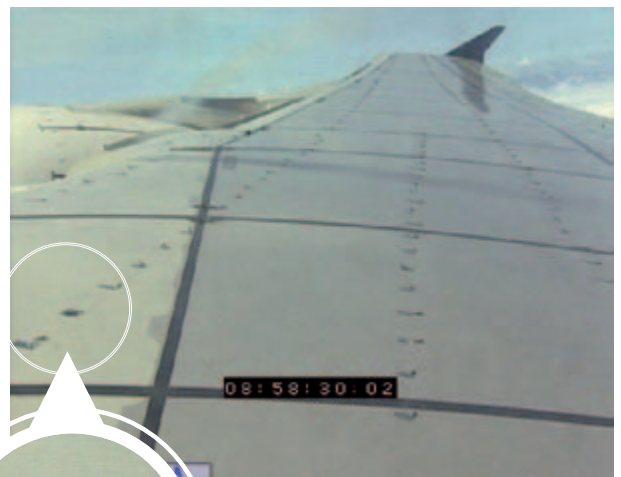
When the AoA reaches the value of the maximum  $C_l$ , the airflow starts to separate.

On this picture (extracted from a video footage), the erratic positions of the flow cones on this A380 wing during a stall test show that the flow is separated.

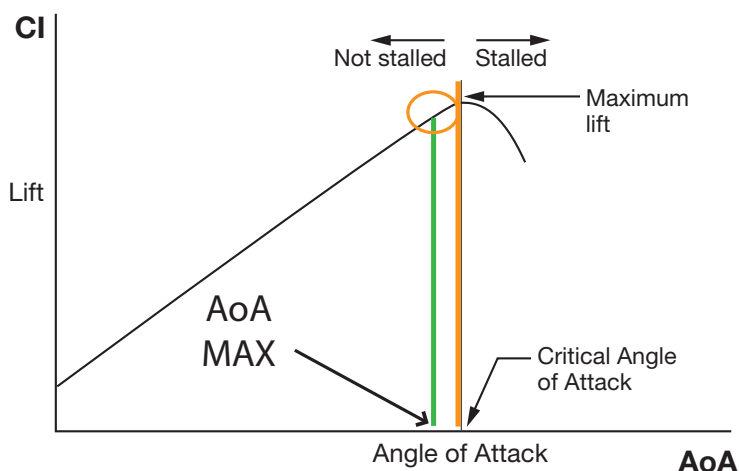
**Figure 1**  
In NORMAL LAW, the EFCS limits the AoA to a value lower than AoA STALL

In NORMAL LAW, the Electronic Flight Controls System (EFCS) takes into account the actual AoA and limits it to a value (AoA MAX) lower than AoA STALL (fig. 1).

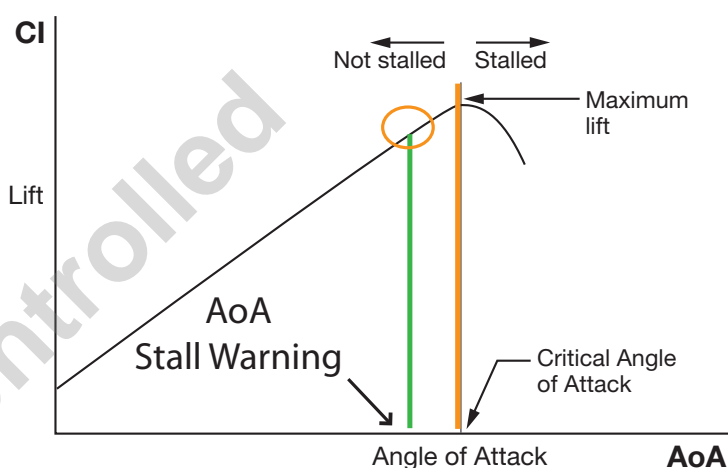
**Figure 2**  
In ALTERNATE and DIRECT LAW, the aural Stall Warning is set at a value lower than AoA STALL

In both ALTERNATE and DIRECT LAW, the aural SW is set at a value called AoA Stall Warning (AoA SW), which is lower than the AoA STALL (fig. 2).

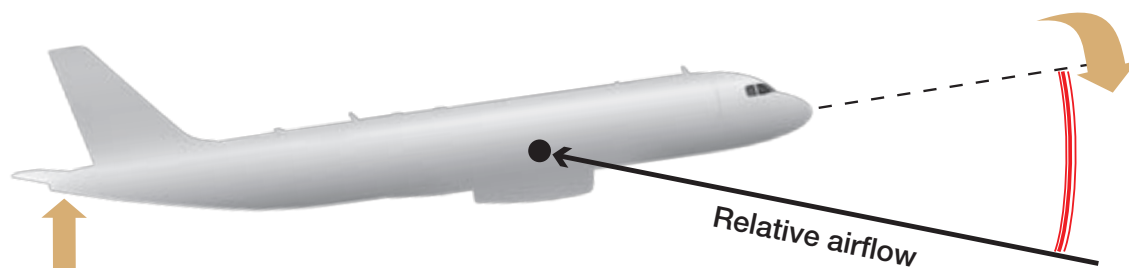
**Figure 3**  
Pitch control  
is a direct  
AoA command

The pitch control is a direct AoA command (fig. 3).

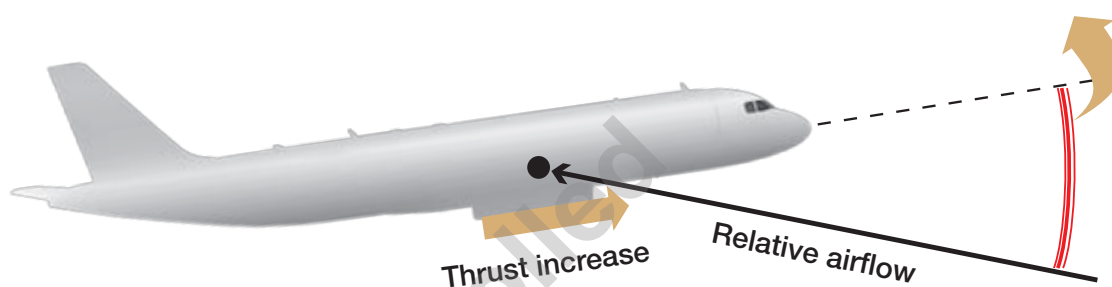
**Figure 4**  
Adding thrust  
leads to an  
increase in AoA

The AoA decrease may be obtained indirectly by increasing the speed, but adding thrust in order to increase the speed leads to an initial adverse longitudinal effect, which tends to increase further the AoA (fig. 4).

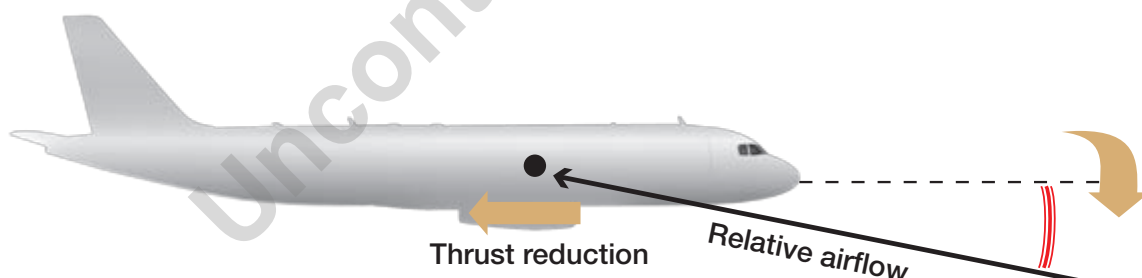
**Figure 5**  
Reducing thrust  
leads to a  
decrease in AoA

Conversely, the first effect of reducing the thrust is to reduce the AoA (fig. 5).

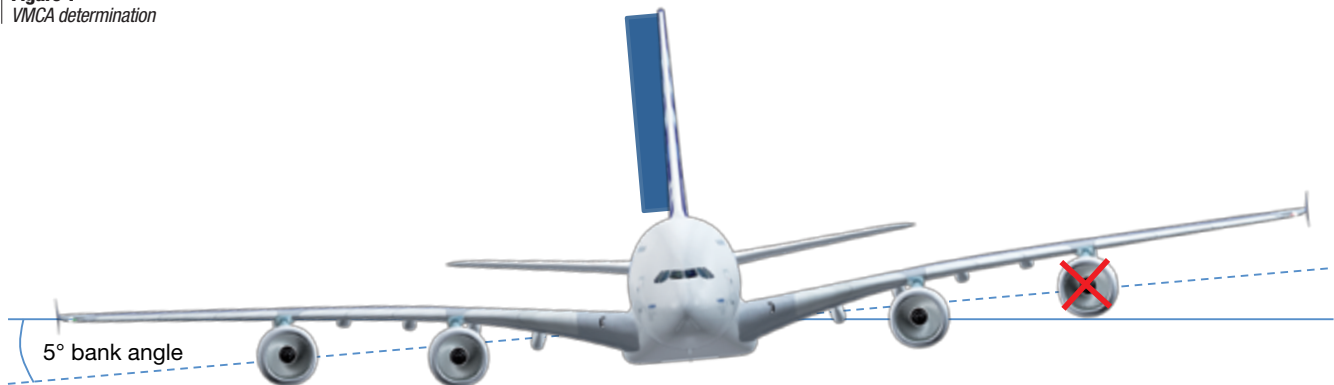
**Figure 1**  
VMCA determination

When engines and systems are configured, we start about 20 kt above the predicted value, then, we decelerate slowly keeping heading constant. Necessary rudder increases as the speed decreases, eventually up to the stop. Further deceleration will need some bank to still keep the heading constant. The “true” VMCA is obtained when the bank angle reaches 5° in the opposite sense to the “failed” engine (**fig. 1**). This bank angle is very important as it allows a further speed reduction of about 5 to 10 kt, compared to the same test performed with wings levelled. Where is this strange rule coming from? It is a mystery! Maybe that, in the old times, when reliable flight test installations were not existing, somebody had imagined to have some tolerance on the bank angle, because it is true that a perfect stabilization of the bank angle is difficult when the rudder is on the stop. In doing so, he put some knots “in his pocket”! Then the tradition has been kept and officialised. This hypothesis could explain the choice of this odd 5° value.

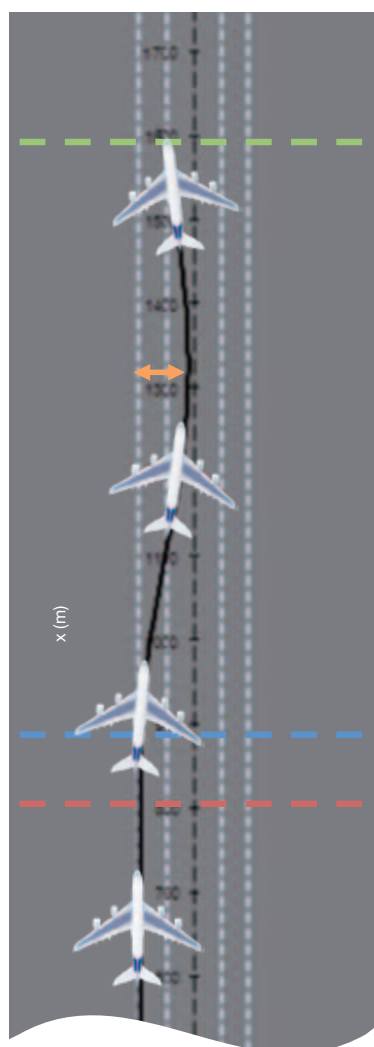
Figure 2  
VMCG test

Rotation

Maximum lateral deviation reached

The VMCG is established with a dynamic test. The aircraft is accelerated with all engines at maximum thrust, with the nose wheel steering disconnected to simulate a wet or contaminated runway. At a given speed, the outer engine is shut down with the master lever. The pilot must try to minimize the lateral excursion, using the rudder (**fig. 2**). As for the VMCA, at high speed a small deflection is needed. But at low speed, even with full rudder, there could be a significant deviation. By definition, the VMCG is the shut down speed for which the deviation is 30 ft.

During this series of tests, the pilot in the left hand seat is in charge of the trajectory. He tries to minimize the deviation and then completes the takeoff when the maximum deviation has been reached. The pilot in the right hand seat shuts down the engine at the planned value.

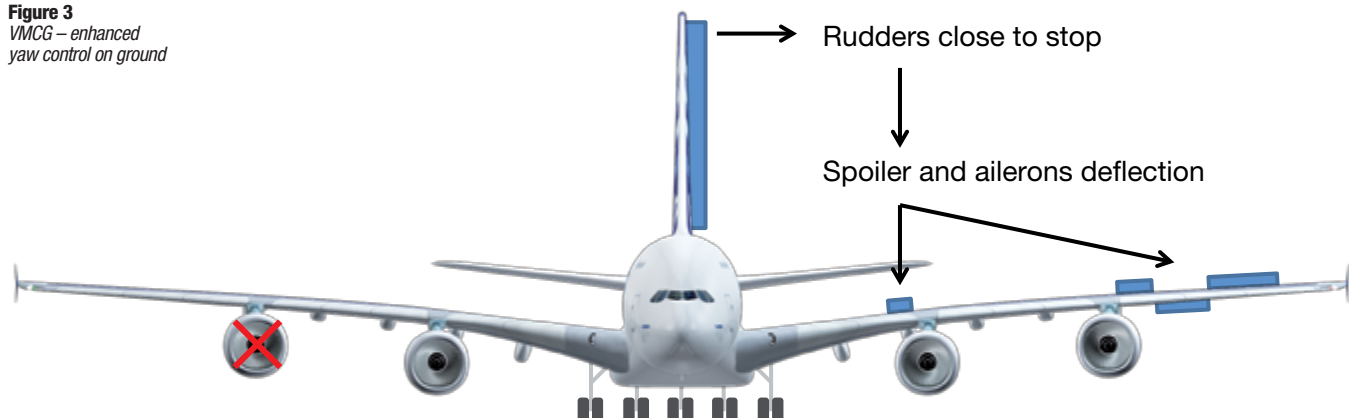
**Figure 3**  
VMCG – enhanced  
yaw control on ground

To improve the situation, it was necessary to enhance the efficiency of the flight controls in yaw after an engine failure. Therefore, in order to create some additional yaw, the solution was to increase the drag on the wing which is on the side of the deflected rudders when they are close to their stop. For that, one spoiler and 2 of the 3 ailerons were fully deflected in the upper direction while the centre aileron was put down (fig. 3). Having ailerons in different directions permitted to minimize the effect on the bank angle. Some modifications were also made in the computers, allowing faster deflection of rudders in this specific situation.

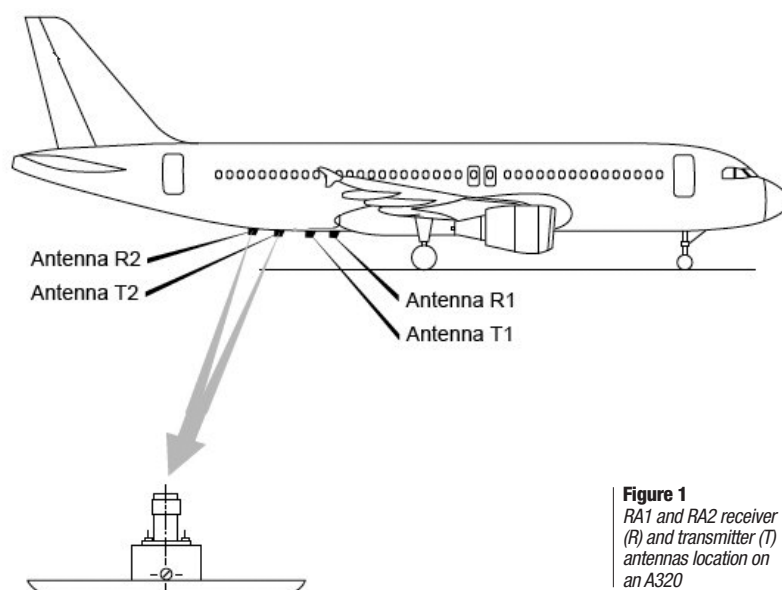
**Figure 1**  
RA1 and RA2 receiver (R) and transmitter (T) antennas location on an A320

All Airbus aircraft, except the A380, are equipped with two RAs, which provide height information to several aircraft systems (fig. 1).

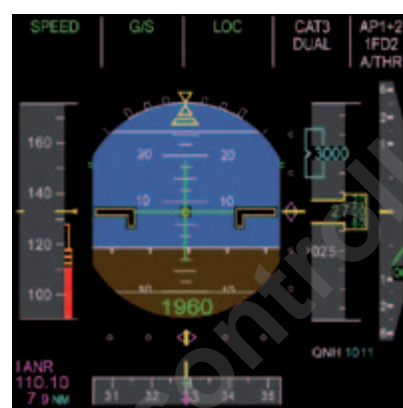
**Figure 2**

Both RAs provide correct height of 1 960 ft

AP1+2  
Engaged

Identical to  
Captain side

► Figure 2 shows the crew's PFDs before the RA1 issue. Both RAs function properly and provide the same height of 1 960 ft. The vertical mode is on G/S, and the lateral mode is on LOC. The A/THR is engaged in SPEED.

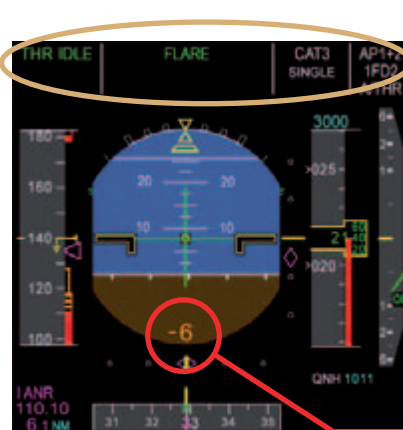
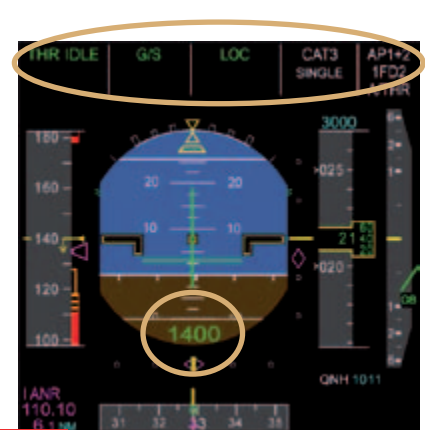
**Figure 3**

Erroneous RA 1 reading is - 6 ft, correct RA 2 reading is 1 400 ft. Both AP/FDs are engaged

AP1+2  
Engaged

Erroneous RA

► Figure 3 RA 1 provides an erroneous height indication of - 6 ft, while RA 2 delivers the correct height of 1 400 ft.

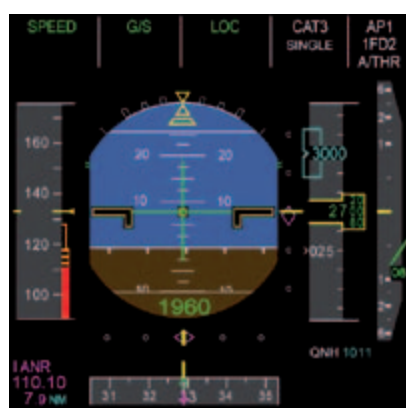
**Figure 4**

Both RAs provide correct height of 1 960 ft

AP1  
Engaged

► Figure 4 shows the crew's PFDs before the RA1 issue. Both RAs function properly and provide the same height of 1 960 ft. The vertical mode is on G/S, and the lateral mode is on LOC. The A/THR is engaged in SPEED.

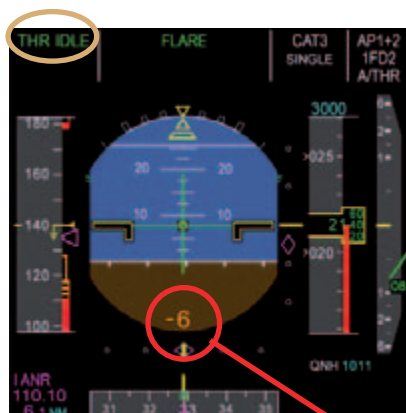
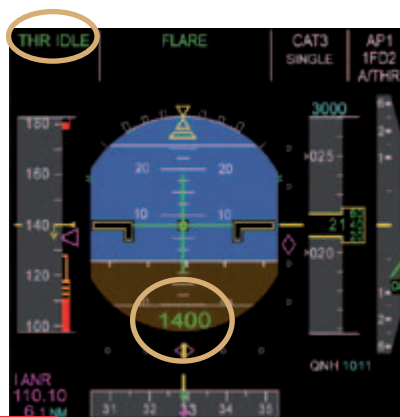
**Figure 5**

Erroneous RA 1 reading is - 6 ft, correct RA 2 reading is 1 400 ft. AP 1 and both FDs are engaged

AP1  
Engaged

Erroneous RA

► Figure 5 shows that RA 1 provides an erroneous height indication of - 6 ft, while RA 2 delivers the correct height of 1 400 ft.

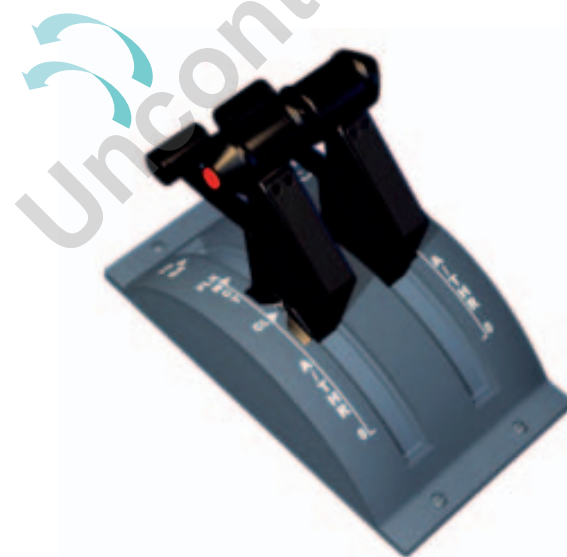
The Go Around is systematically initiated by pushing the thrust levers to TOGA.

This ensures the engagement of the Go Around Track (GA TRK) Auto Pilot and/or Flight Director lateral mode<sup>1</sup>.

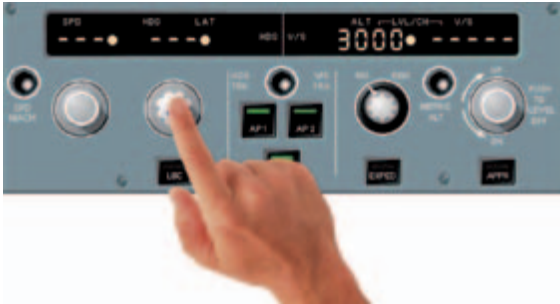
The crew has to arm the NAV mode manually by pushing on the FCU HDG/TRK knob.

Then, the FMA displays the NAV mode.
